RESEARCH NOTE NC-29

Waterline Erosion Control Essential To Streambank Rehabilitation

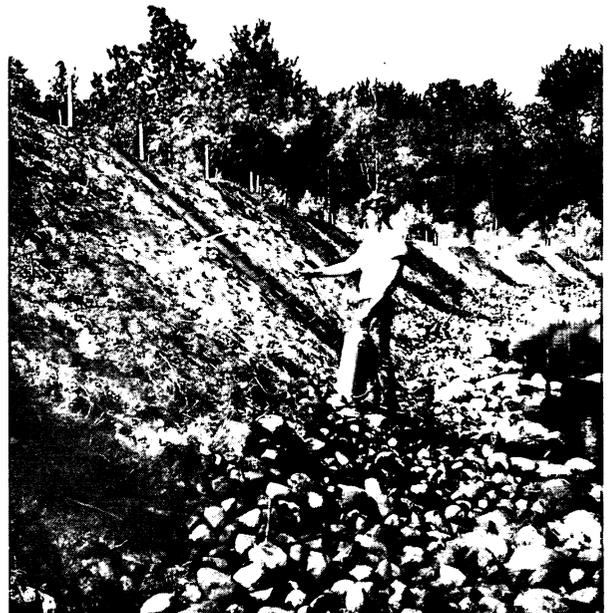
F-506035

Figure 1.—Liquid mulch being sprayed on a bank above rock rip-rap.

All banks were graded before treatment. Some banks were seeded with a mixture of creeping red fescue, perennial rye, and blue grass, and top-dressed with approximately 2 tons per acre of slow-release 16-16-16 fertilizer. The test banks were divided into 10- to 20-foot-wide strips; each strip was sprayed with one of six different asphalt and latex base liquid mulches (fig. 1). The tests on

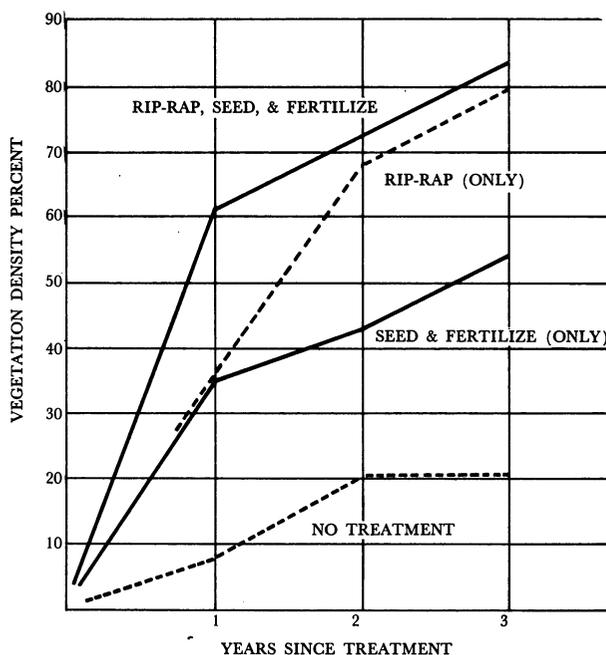
Figure 2.—Effect of bank treatment and time on vegetation density.

Seeding and fertilizing accelerated revegetation of the banks (fig. 2), but after 2 years vegetation on unseeded rip-rapped banks had nearly caught up with that on seeded, rip-rapped banks. This was possibly due to introduction of seed with rock rip-rap which was obtained from field stone piles.
